Grounding of *ABFC Roebuck Bay*

Henry Reef, Queensland | 30 September 2017

ATSB Transport Safety Report
Marine Occurrence Investigation
MO-2017-009
Final – 27 June 2019

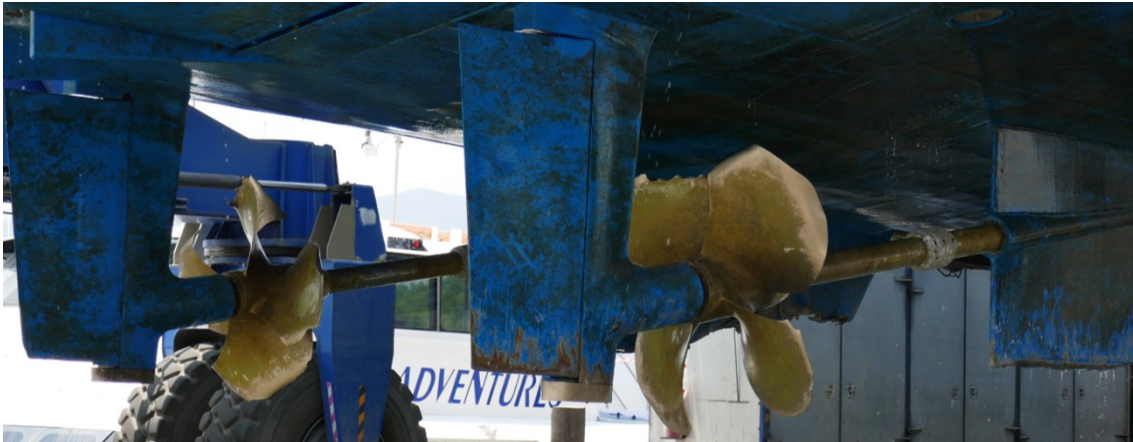
Figure 10: Damage to ABFC Roebuck Bay's propellers, rudders and skegs

Externally, the port and starboard ride control fins were found holed and bent. Similarly, the port and starboard skegs were found breached with a loss of watertight integrity and both stern tubes had sustained misalignments. The port and starboard propeller blades were also found to have

sustained extensive damage, especially to the blade tips, and both rudders showed minor deformation to the lower section of their trailing edges (Figure 10).¹⁶

¹⁶ The cutter has since been repaired and, after a period of sea trials, was returned to active service in September 2018.

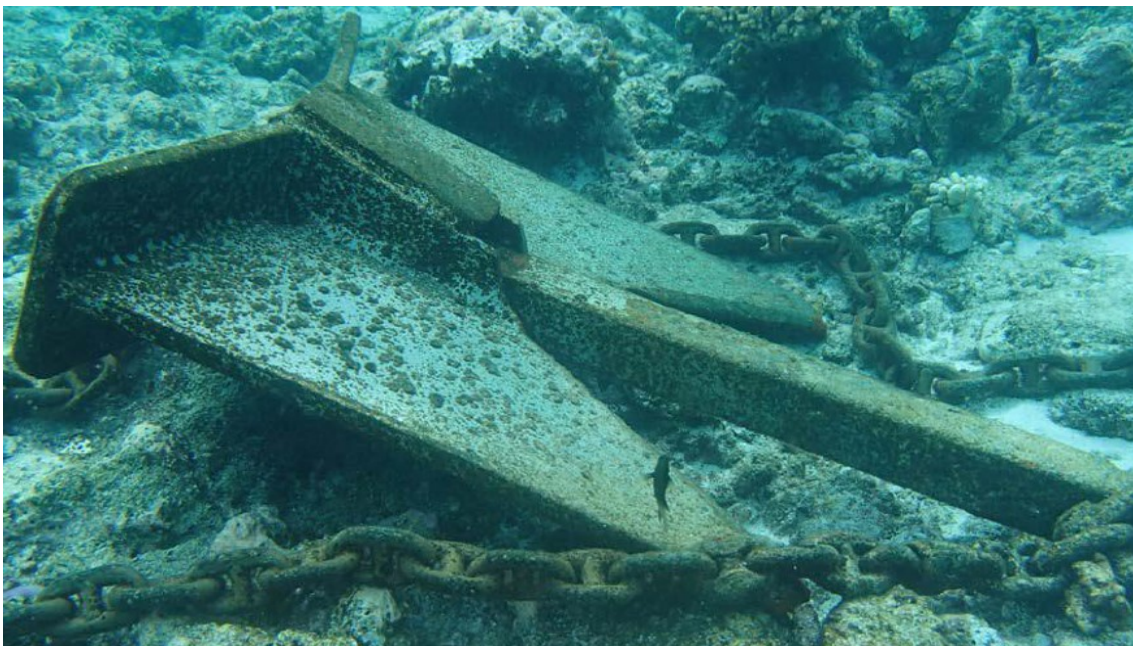
Figure 11: ABFC Roebuck Bay's anchor and chain on Henry Reef

In October 2017, officers from the Great Barrier Reef Marine Park Authority and Queensland Parks and Wildlife Service conducted a site assessment of Henry Reef. The assessment found that the maximum extent of physical reef damage occurred within an area of about 990 m² on the north-western aspect of Henry Reef.¹⁷ At the time of the assessment, ABFC Roebuck Bay's 184 kg anchor and about 150 m of anchor chain remained on the reef (Figure 11).

The assessment report concluded with recommendations to remove the anchor, chain and any other metal and anti-foul paint still on-site and to stabilise coral debris on the reef. In November

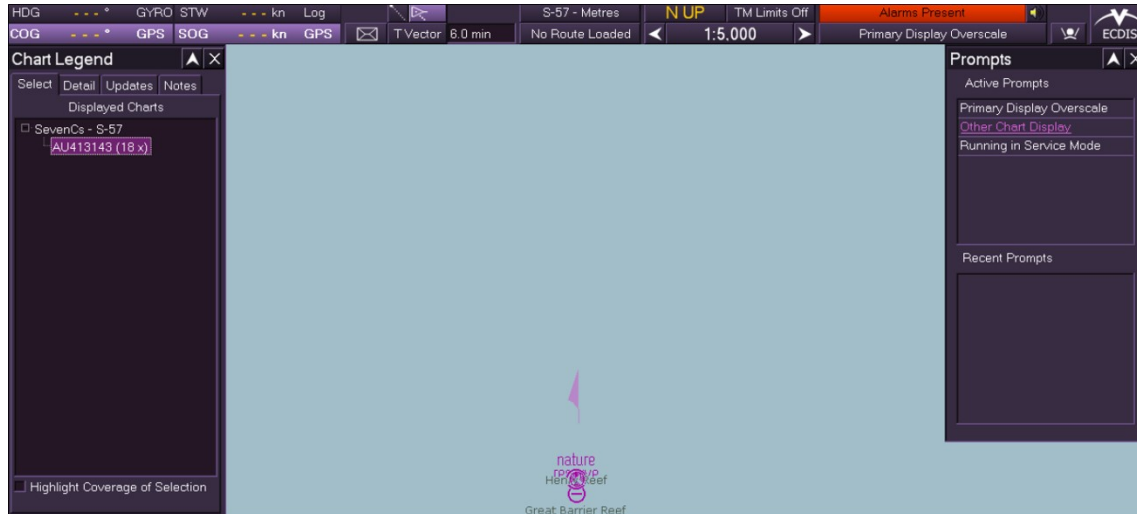
Figure 14: Image of ENC AU413143 showing no overscale pattern

Image of a VisionMaster FT ECDIS display showing ENC AU413143 at a scale of 1:5,000 and displaying no overscale pattern. Source: Northrop Grumman Sperry Marine, modified by the ATSB

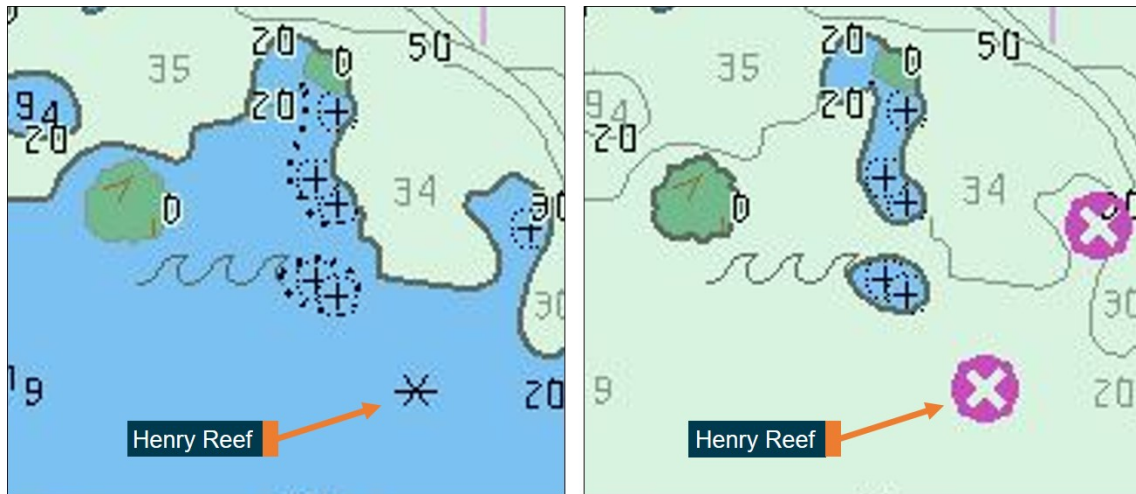
Figure 19: Henry Reef on ENC AU413143, displaying conditional symbology

Image on left shows Henry Reef displayed as a 'rock awash' symbol when lying within the user-defined safety contour. The image on the right shows Henry Reef displaying as an 'isolated danger symbol' when lying outside the user-defined safety contour.
Source: Australian Hydrographic Office, annotated by the ATSB

The IHO presentation library applicable at the time of the grounding, PresLib 4.0, mandated that the user be given the option of displaying the isolated danger symbol even for features in waters shallower than the safety contour value. However, some ECDIS operating on previous versions of the presentation library, including the ECDIS on board *ABFC Roebuck Bay*, always displayed the isolated danger symbol for applicable features regardless of their location in relation to the safety contour. Therefore, on *ABFC Roebuck Bay*'s ECDIS, Henry Reef always displayed as an isolated danger symbol.

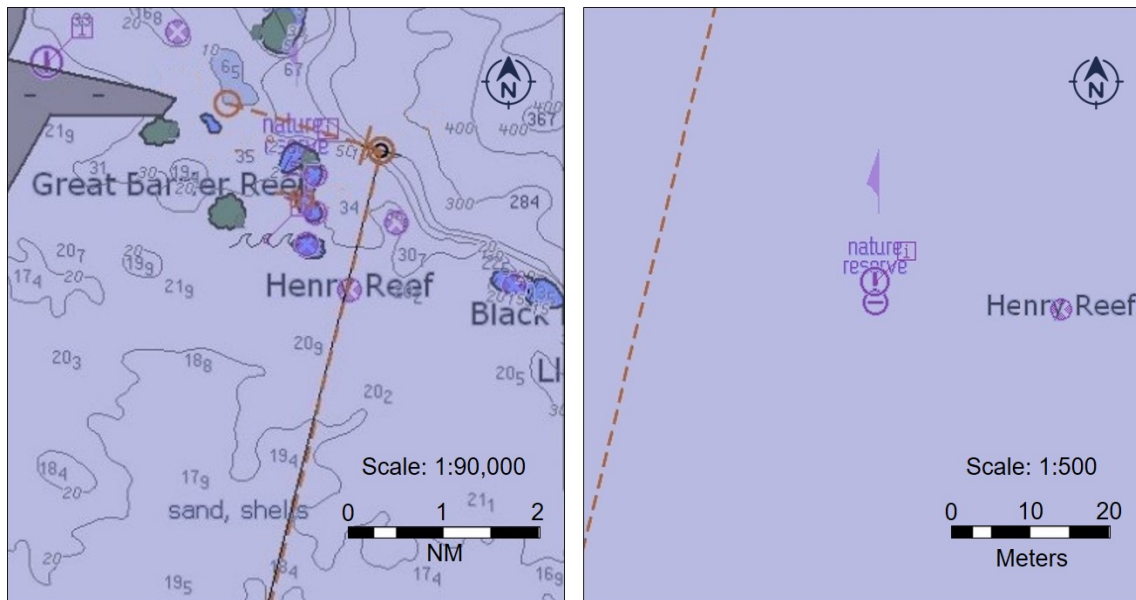
Figure 27: ABFC Roebuck Bay's planned route on the ECDIS showing the relative position of the isolated danger symbol representing Henry Reef at different scales

Image shows ABFC Roebuck Bay's amended route legs on the ECDIS at the compilation scale of 1:90,000 (left) and at the largest viewable scale, 1:500 (right). Source: Electrotech and ATSB

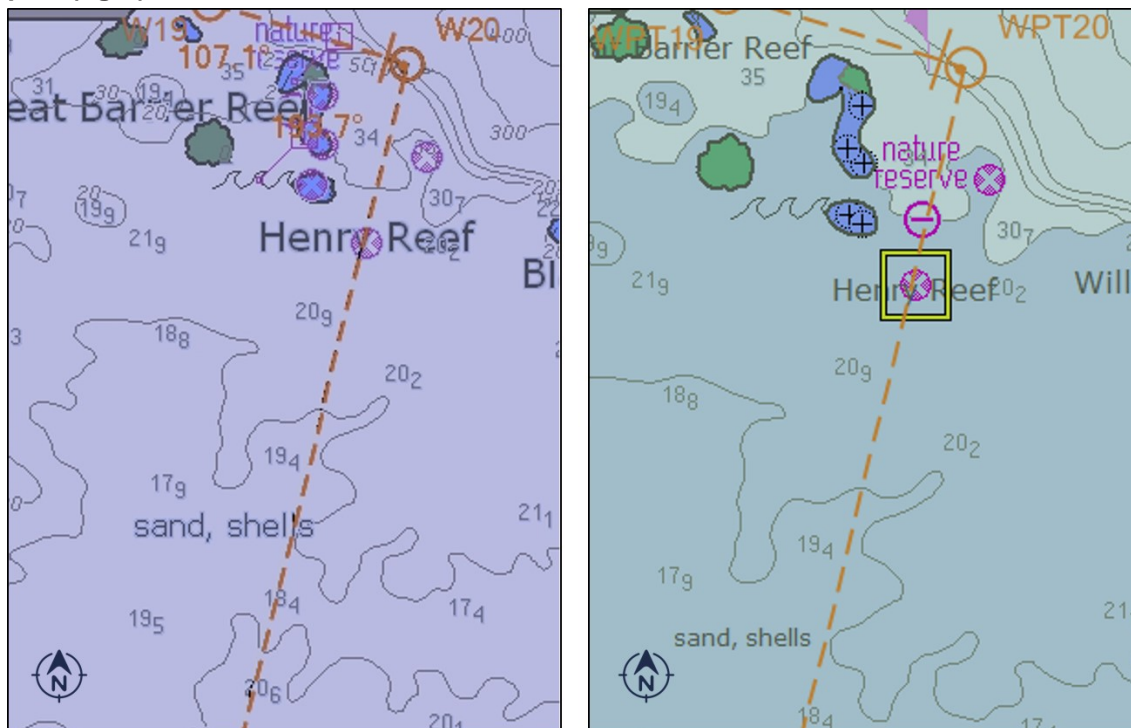
Figure 33: Images of ECDIS operating on PresLib 3.4 (left) and ECDIS updated to PresLib 4.0 showing indication highlight feature demonstrated on the amended route plan (right)

Image shows the amended route plan as it probably appeared on board ABFC Roebuck Bay (left) and as it might have appeared had the ECDIS been updated to PresLib 4.0 (right).
