Grounding of *ABFC Roebuck Bay*

Henry Reef, Queensland | 30 September 2017

ATSB Transport Safety Report
Marine Occurrence Investigation
MO-2017-009
Final – 27 June 2019

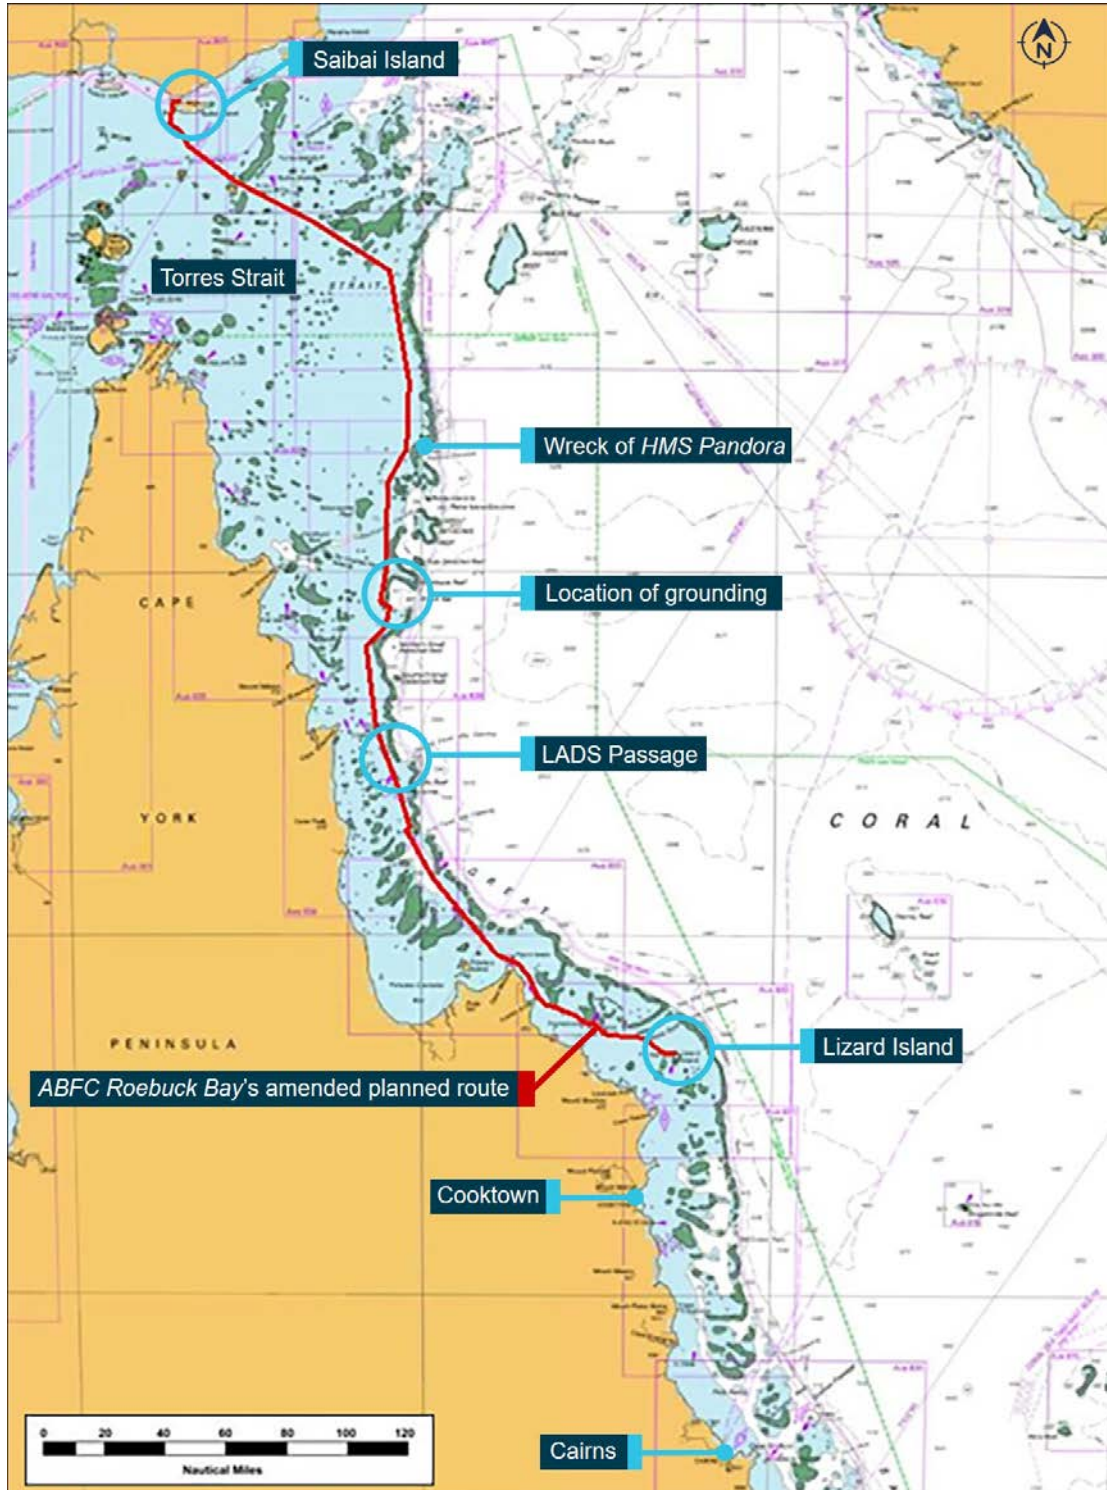
Figure 3: Section of navigational chart Aus 4620 showing ABFC Roebuck Bay's planned route and key locations

The passage plan was subsequently split into two routes with a brief stop at Lizard Island, Queensland before continuing on to Cairns for the end of the patrol. The two routes were then saved on the cutter's ECDIS and named 'Saibai to Lizard via Outer Reef' (Figure 3) and 'Lizard to Cairns'. No further changes were made to the route plan.

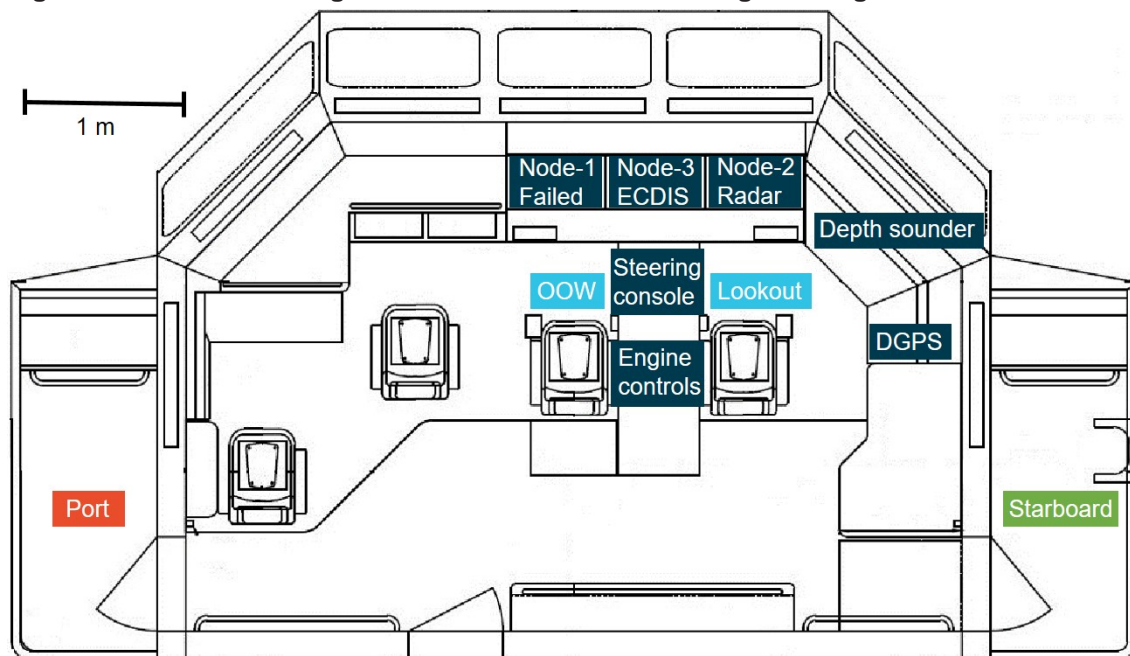
Figure 4: Location of bridge team members at the time of grounding

While on watch, the OOW was seated with the non-functioning display to his front and the ECDIS display his right. The lookout was seated in front of the radar display (Figure 4). The OOW used the ECDIS to review the cutter's expected passage over their coming watch and briefed the lookout accordingly. The OOW confirmed with the lookout that the depth sounder's shallow water alarm was set at 10 m. The lookout was also advised to switch periodically between the radar's 6 NM and 12 NM range scales on node-2.

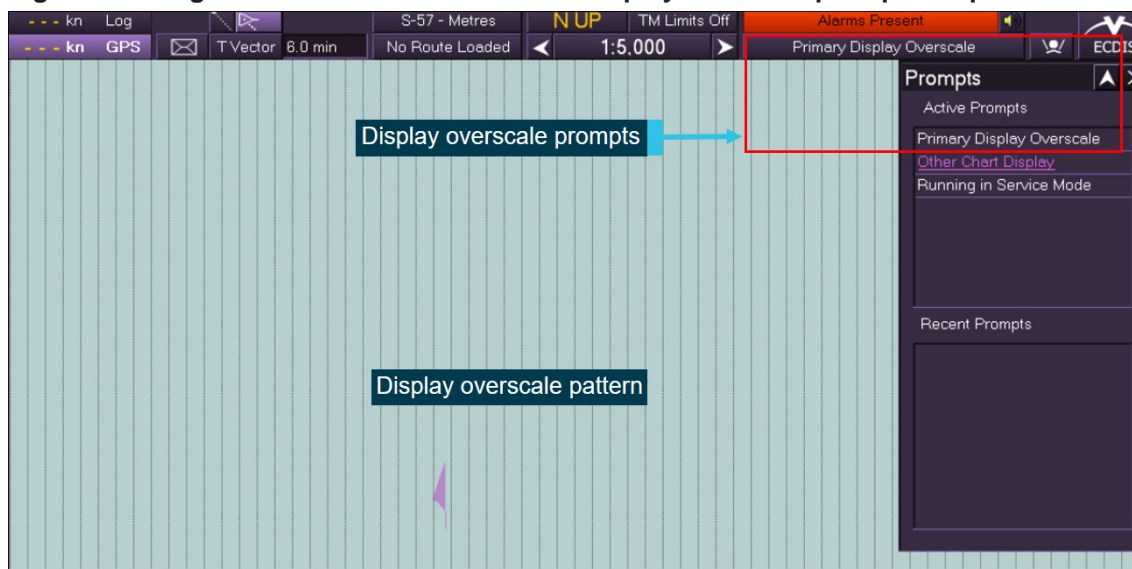
Figure 13: Image of a VisionMaster FT ECDIS display overscale prompt and pattern

On the VisionMaster FT ECDIS, depending on the display option, a 'Primary Display Overscale' or 'Secondary Display Overscale' prompt appeared in the upper right-hand corner of the display when the chart was displayed at a scale larger than its compilation scale (Figure 13). With regard to the overscale pattern, the VisionMaster FT user manual stated that the pattern was generated by the ECDIS if the scale of the display was more than double the compilation scale of any chart in the display.

Image shows the overscale display prompt and overscale pattern demonstrated on a different ENC of the same navigational purpose code and compilation scale as ENC AU413143.

During tests on chart AU413143, conducted by the ATSB and the manufacturer, it became apparent that, while the overscale text prompt appeared when the chart was viewed at scales larger than the compilation scale, the overscale pattern was not generated regardless of the scale at which the chart was viewed (Figure 14). However, the pattern did appear on other charts of the same compilation scale and navigational purpose as ENC AU413143 (see Figure 13).

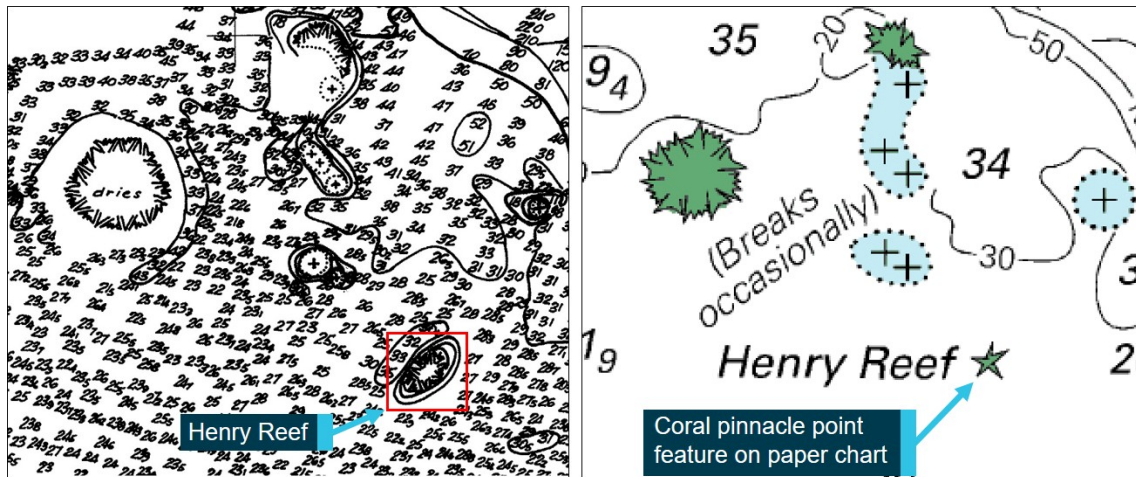
Figure 18: Survey data (left) and section of paper chart Aus 836 (right)

Henry Reef was an identified geographical feature that was charted on official charts of the Great Barrier Reef. The original survey data, obtained in 1977, was compiled at a scale of 1:50,000 and then used to compile the paper chart Aus 836 at a scale of 1:150,000 (Figure 18).

Image shows Henry Reef as surveyed (left) and Henry Reef represented by the 'coral pinnacle' symbol (right) on the paper navigational chart Aus 836.

Based on the paper chart's compilation scale and other factors, reefs of a certain size were represented as area feature objects while smaller sized reefs were represented by point feature objects. The AHO assessed that Henry Reef could be adequately represented by a point feature object. The symbol used to represent the reef was the 'coral pinnacle' symbol—a green, 5-pointed star-shaped symbol (Figure 18). The coral pinnacle symbol was used to represent coral reef point feature objects on Australian paper charts. This symbol was unique to Australian charts and has not been adopted into the IHO list of chart symbols and abbreviations.

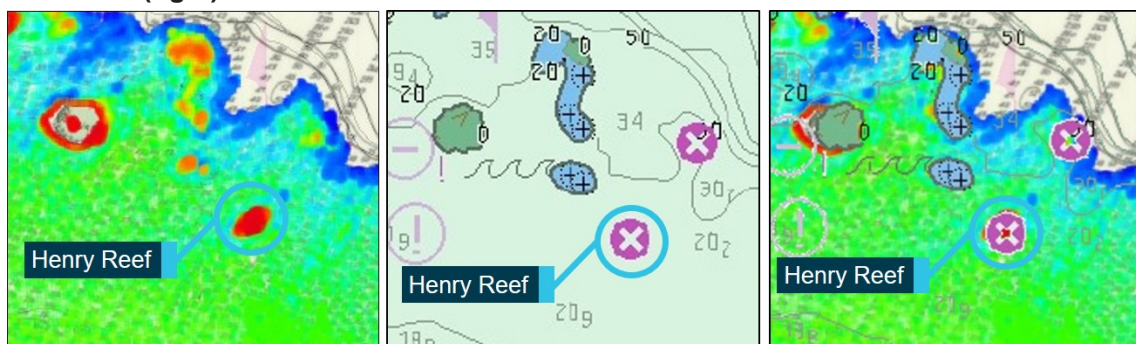
Figure 20: AHO survey data (left), AU413143 (centre) and survey data overlaid on AU413143 (right)

A cursory analysis of AHO survey data⁵³ obtained shortly after the grounding showed that, when superimposed on ENC AU413143 at compilation scale and, taking into account the position accuracy limits defined by the appropriate CATZOC, the isolated danger symbol appears adequately representative of the observed extent of Henry Reef (Figure 20). However, when viewed at scales progressively larger than the compilation scale, the symbol would progressively represent a smaller proportion of the reef on the ECDIS display.

Images show AHO survey data (left), section of ENC AU413143 (centre) and ENC AU413143 superimposed on survey data at compilation scale (right).
Source: Australian Hydrographic Office, modified, annotated and superimposed by the ATSB

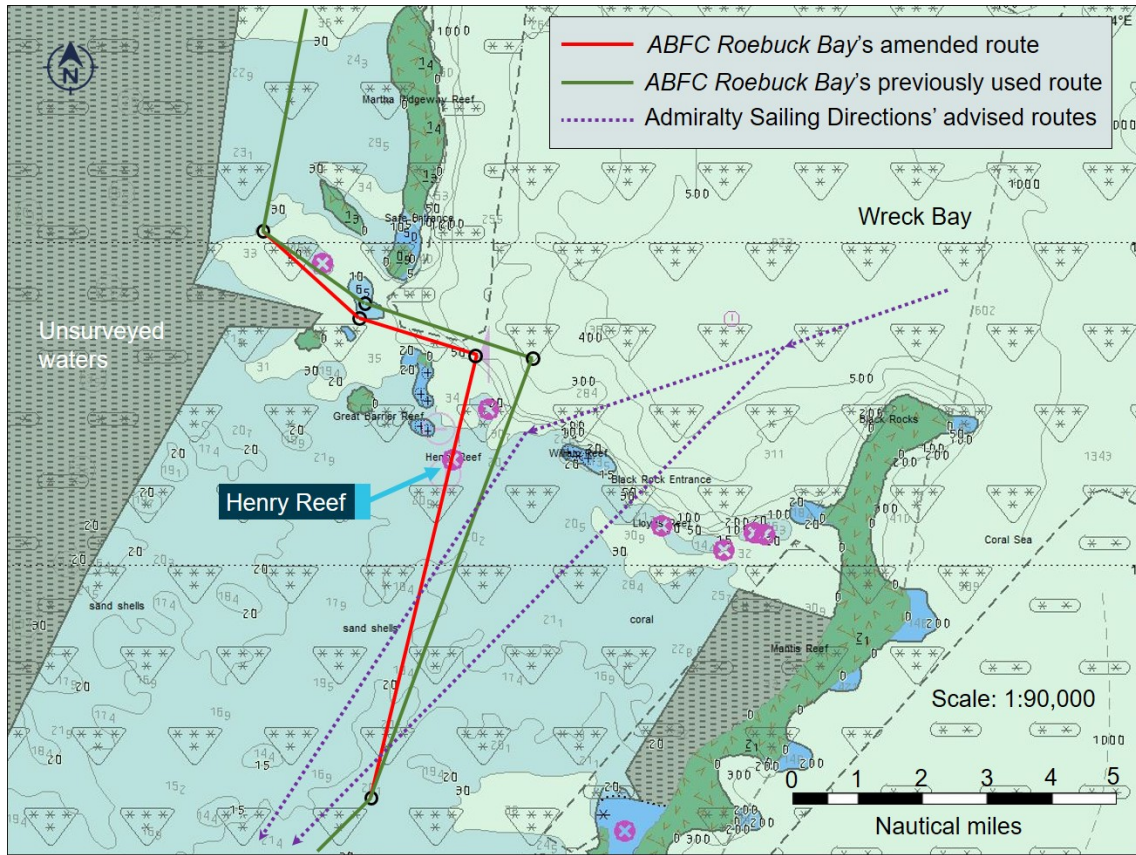
Figure 23: Section of ENC AU413143 showing CATZOCs and ABFC Roebuck Bay's routes compared to advice in the Admiralty Sailing Directions

The sailing directions provided information for safe navigation that was not available on charts or in other hydrographic publications. The sailing directions provided advice for small vessels on routes leading south through Wreck Bay (Figure 23). While the directions cautioned that these routes were not normally used, there were often operational reasons for ABF cutters to navigate in waters that would generally be beyond the scope of regular merchant vessels. The directions also advised that these routes could not be considered proven safe by regular use.

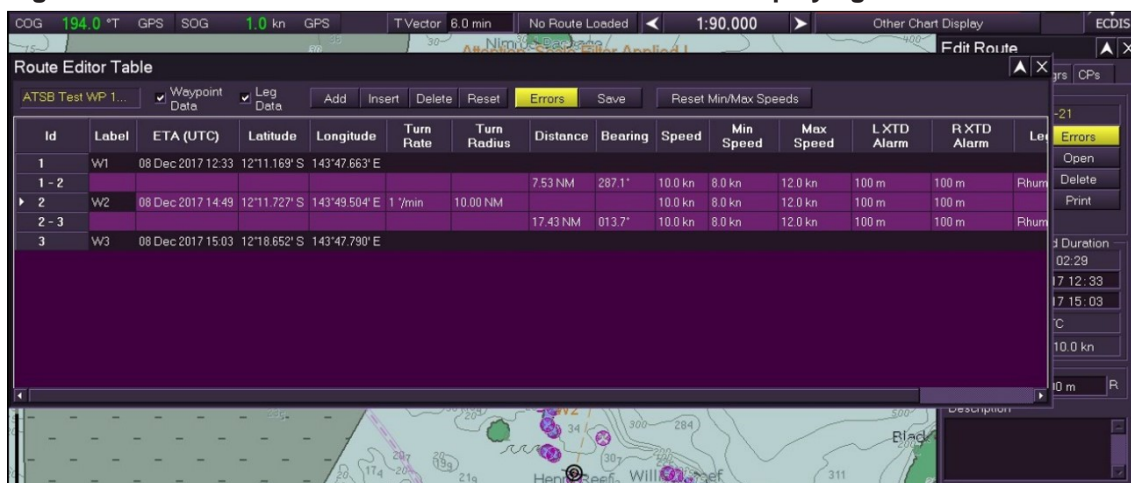
Figure 24: VisionMaster FT ECDIS route validation check displaying 'Errors'

The route validation check examined the geometry of the route and if there were no errors, a tab displayed the words 'No Error'. If an error was detected (such as an incorrect turn radius),⁶⁸ the tab displayed the word 'Errors' with a yellow background (Figure 24). A route could be saved if it contained errors, but could not be loaded for monitoring until the errors had been rectified. The route validation process did not check the route for dangers

Image shows a VisionMaster FT ECDIS displaying the 'Errors' highlighted in yellow due to an incorrect turn radius entered by ATSB investigators during testing.

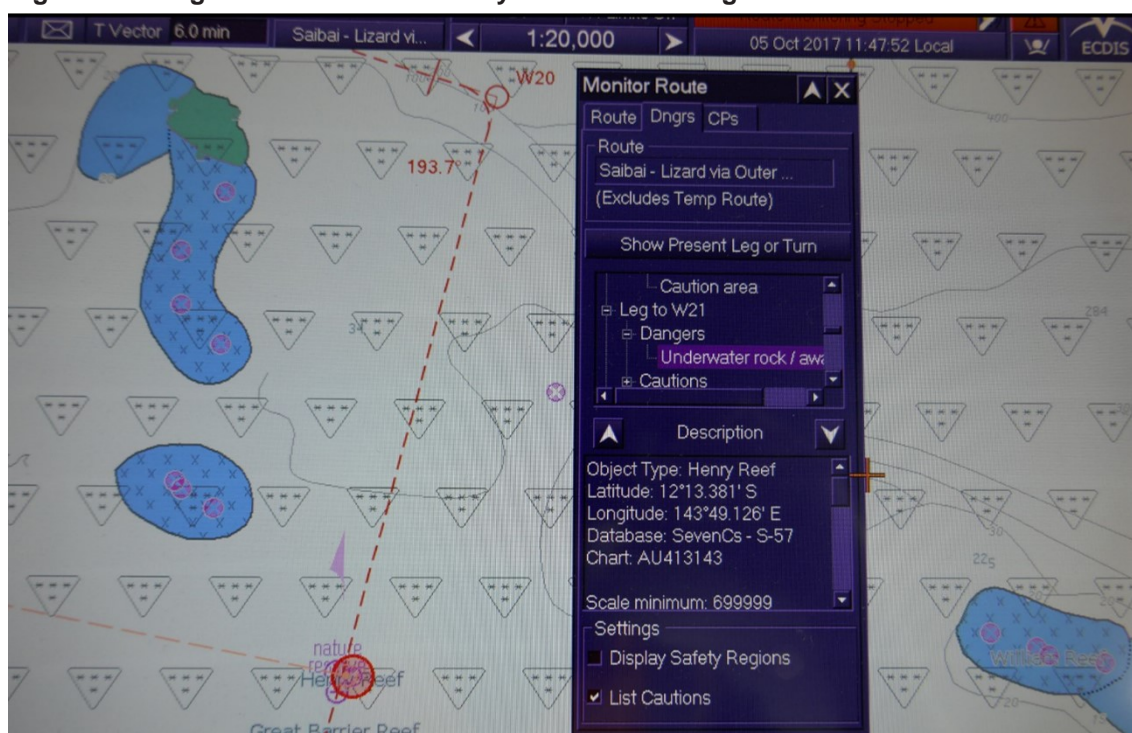
Figure 28: Image of ABFC Roebuck Bay’s ECDIS showing the ‘Monitor Route’ window

ATSB examination of *ABFC Roebuck Bay’s* ECDIS after the cutter’s arrival in Cairns confirmed that Henry Reef had been identified by the ECDIS and listed in the ‘Monitor Route’ menu’s dangers tab folder (Figure 28). As discussed previously, the ‘Monitor Route’ dangers tab folder replicates the dangers identified in the ‘Edit Route’ dangers tab folder. Therefore, it was almost certain that Henry Reef was identified as a danger by the ECDIS in the ‘Edit Route’ dangers tab folder as well. This was confirmed during ATSB testing (see Figure 29).

Image of *ABFC Roebuck Bay’s* ECDIS showing an identified danger (Henry Reef) on the leg to W21 in the dangers tab folder of the ‘Monitor Route’ window. Selecting the danger highlights the reef graphically on the ECDIS display and provides available information on Henry Reef. Source: ATSB

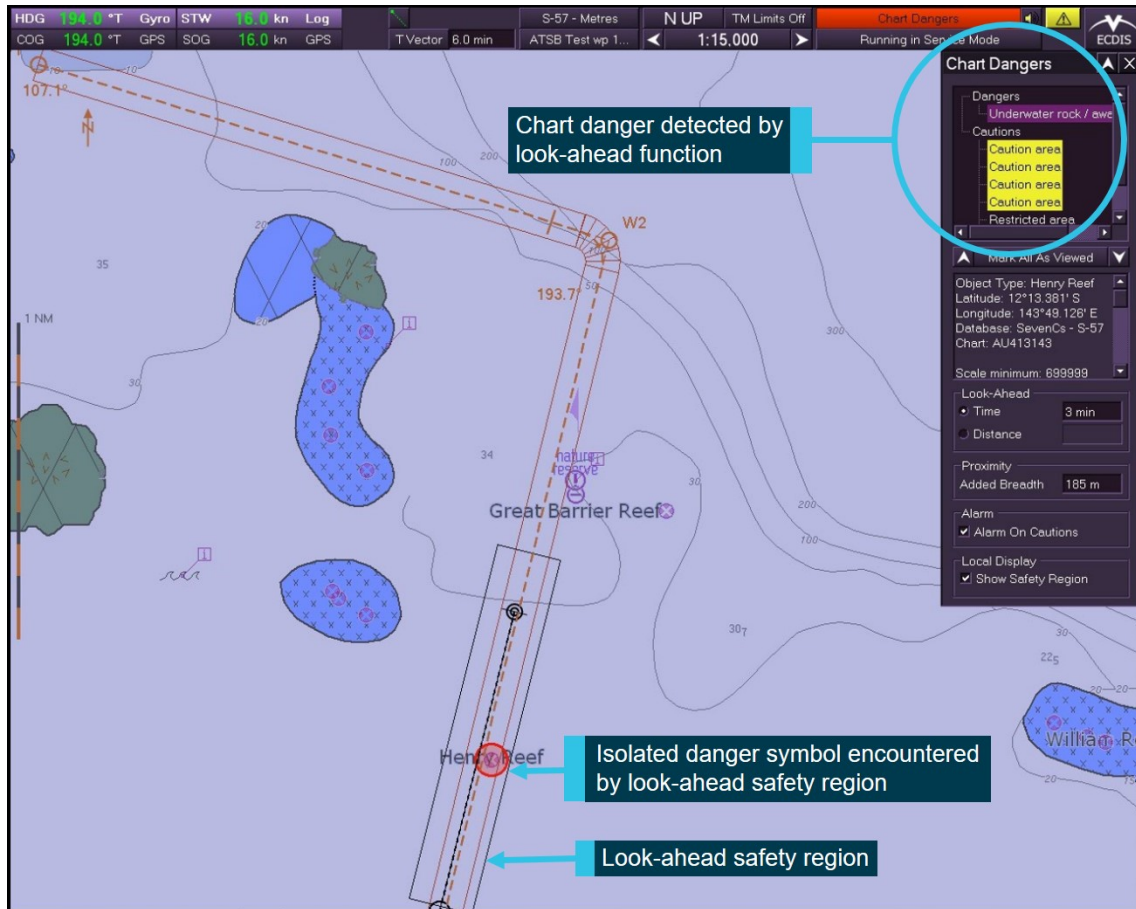
Figure 31: Image showing Henry Reef, detected by the look-ahead function during testing, based on the ‘restricted waters’ setting

ATSB tests using settings recommended in the 'restricted waters' category of the Annex C checklist in the ECDIS work instructions, namely the use of an added breadth of 0.1 NM (185 m), significantly increased the chances of the look-ahead function detecting the reef (Figure 31).

Image from ATSB testing showing Henry Reef being detected by the ECDIS's look-ahead function when set up with a 0.1 NM (185 m) added breadth based on settings in the Annex C – Restricted waters category checklist of the ABF work instructions. Selecting the danger highlights the reef graphically on the ECDIS display and provides available information on Henry Reef.

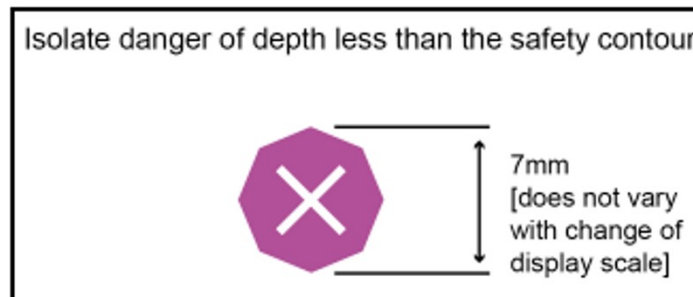
3. At the intended maximum compilation scale, details which are too small to chart, but which still present a hazard to navigation, are typically replaced by a symbol larger than the charted size of the feature (such as a very small reef). Zooming in to over-scale destroys the relationship between the size of the (now larger) hazard and the size of the symbol.

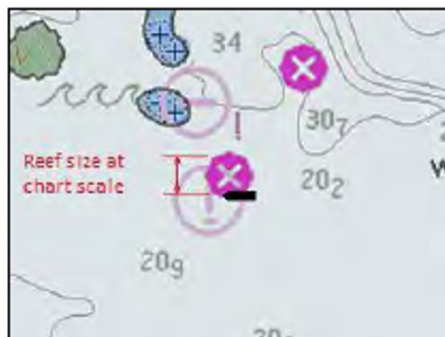
4. When the ENC is displayed correctly, the danger to a ship close to an isolated danger is clear.

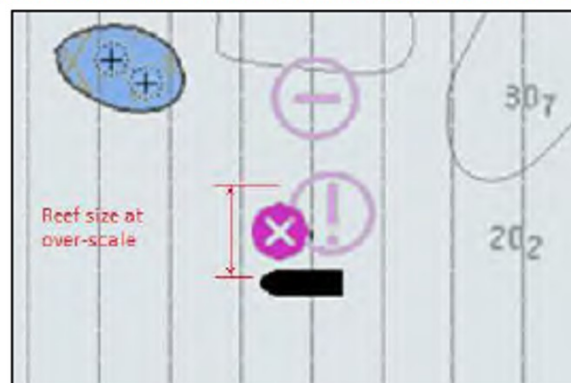
5. However, when displayed at over-scale, a ship the same unsafe distance from the isolated danger incorrectly appears to be safe because the isolated danger symbol is still the same size.

6. This is not more accurate, and is definitely not safe.
7. Remember, the positioning accuracy of the isolated danger may be worse than 500 metres. Routes should be planned to clear these dangers by at least as far as the ZOC category immediately around the danger dictates.
